Subject	High Capacity Frog-6 and Frog-9
Issue Date	31 June 2009
Number	01/09 – R000

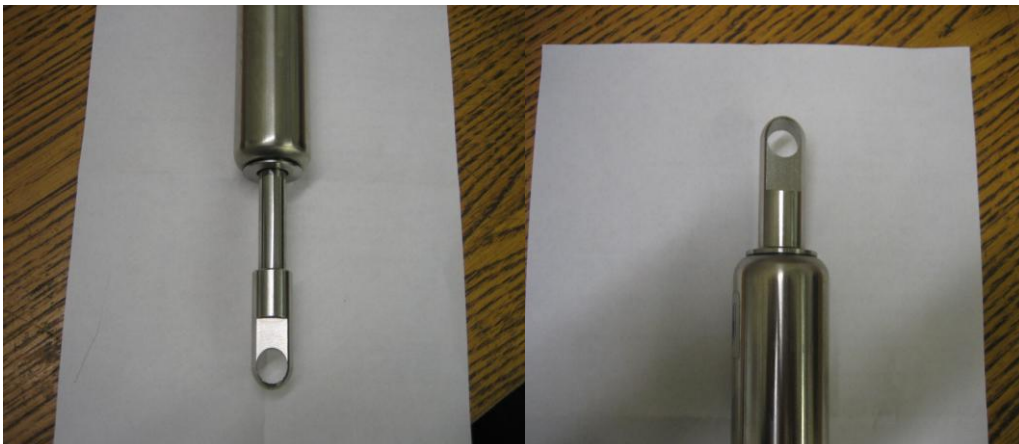
A report has been received by Reflex Marine Ltd. that during a pre-operational check on a Frog 6 it was found that one of the seat dampers had rotated.

This caused the top and bottom clevis' to start unscrewing from the hydraulic damper assembly.

Any unscrewing of the clevis can be confirmed by ensuring that no thread is visible between the clevis and the cylinder or rod. See attached photos of the top and bottom clevis in the fully assembled position.

If any thread is visible, it will be necessary to remove the clevis and clean the male and female thread with a non-residual cleaner to remove all grease, oil and dirt. After cleaning, apply Loctite 290 in accordance with the manufacturer's instructions and refit the clevis.

The clevis must then be tightened to the end of the thread, and the left for the period recommended by Loctite to allow the bond to set, before returning it to service.
